Shoreline Stabilization Project

2015 Little Birch Lake

Shoreline Stabilization

Little Birch Lake

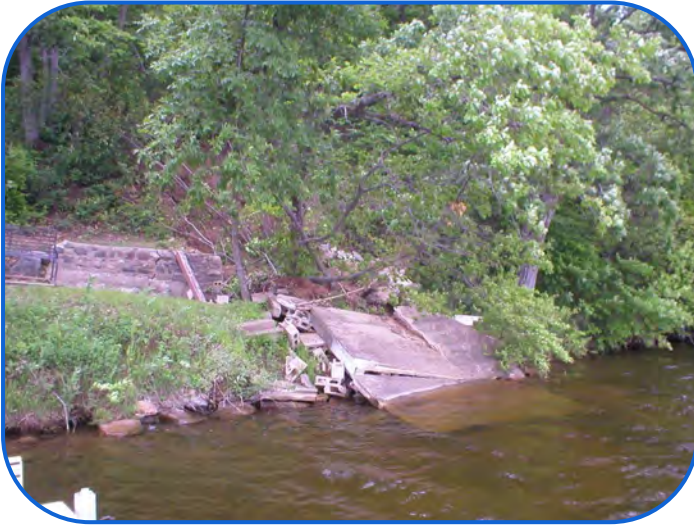
Before Project – Boathouse/Bluff Failure

Project Description : This site consists of a very steep bluff to Little Birch Lake along 110 feet of shoreline. There was an existing boathouse constructed into the bluff. During the summer of 2014, the bluff and boathouse collapsed resulting in the materials being deposited on the shoreline and in the lake. As a contributing factor to the bluff failure, the stormwater from the cabin on the property was routed down the bluff. In addition, near the shore there was a failing retaining wall. The bluff restoration and boathouse removal were completed in two phases. In March of 2015, the boathouse debris removal and bluff restoration was completed. This portion was done by accessing the site from the lake over the ice. During the bluff restoration, soil was hauled in and compacted to restore the slope, reshaping of the shoreline was completed, a diversion was constructed with a filter basin and outlet, and native grasses, wildflowers as well as a cover crop were seeded. Coconut erosion control blanket and sediment logs were also installed. In May of 2015 the second phase of the project was completed. This involved the rerouting of the cabins stormwater, as well as planting native tree and shrubs on the restored bluff.

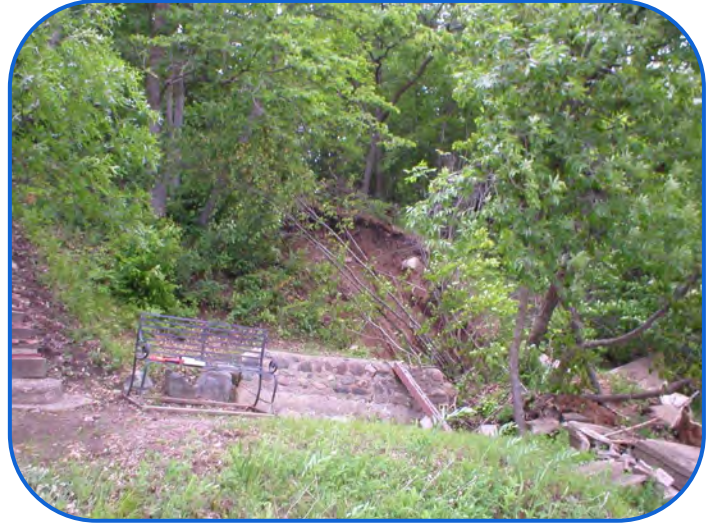
Before Project – Boathouse/Bluff Failure

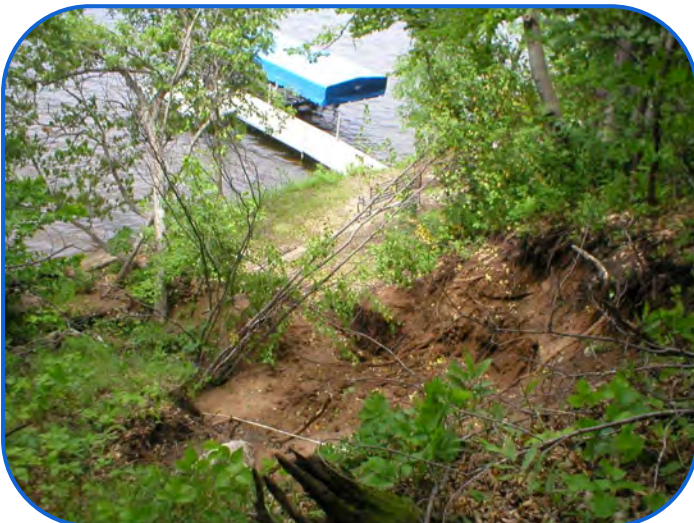
Before Project – Bluff Failure

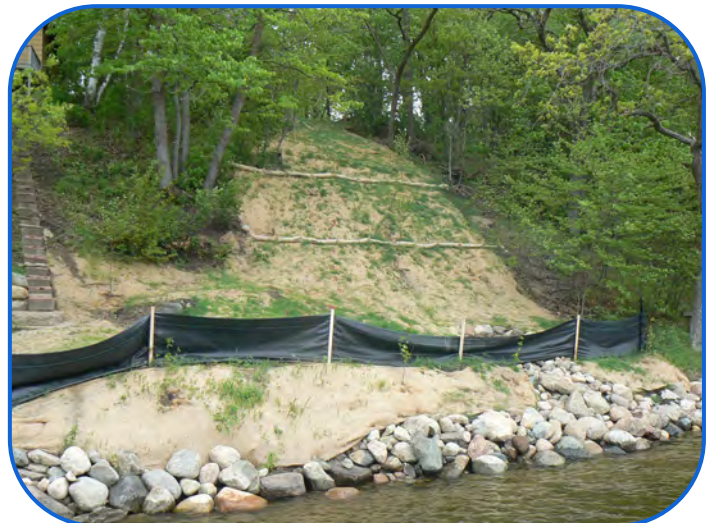
After Project – Bluff/Shoreline Restored

- Bluff/Slope Failure
- Boat House Collapse Into The Lake
- Retaining Wall Removal
- Stormwater Management
- Sediment Logs
- Coconut Erosion Control Blanket
- Native Planting

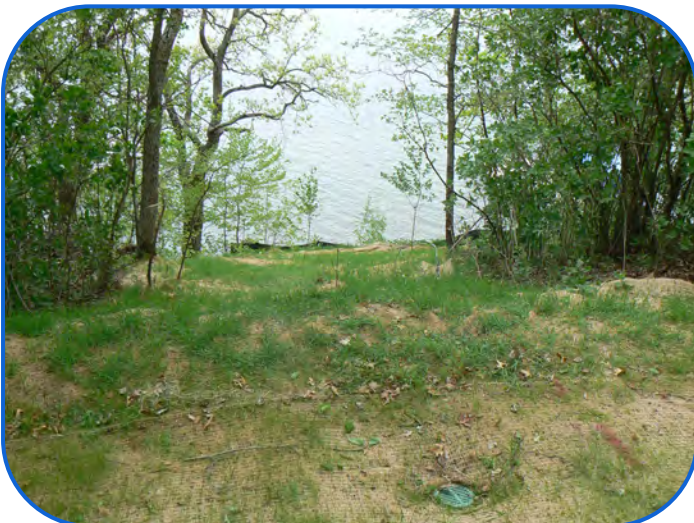
After Project – Bluff/Shoreline Restored
